**Terracotta as Heritage Evidence: Legibility, Surface Loss and Conservation Intervention across Islamic and Hindu Monuments in Bagerhat, Bangladesh**

**Monisa Saha**

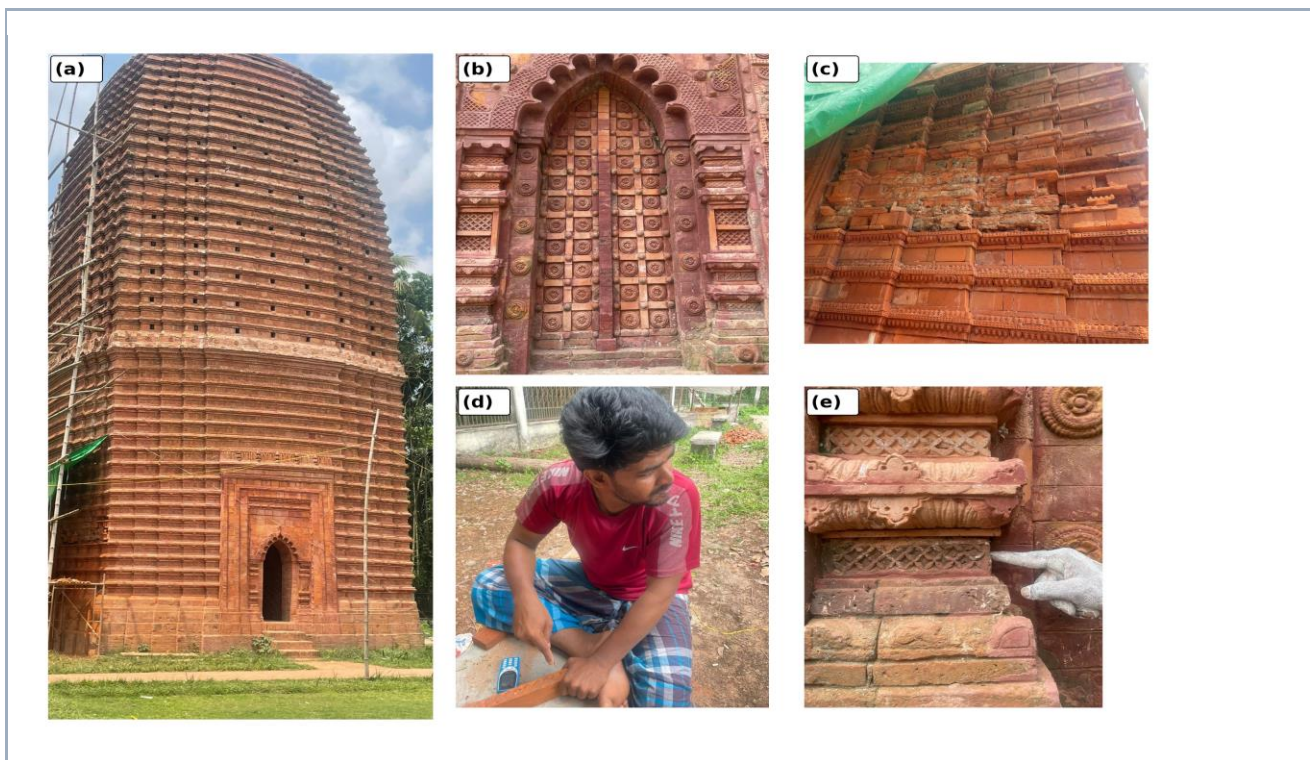
Evidence of the primary intervention is quite clear and includes: scaffolding and tarpaulins, open loss areas, repair materials being prepared on site, loose or stored decorative pieces and artisans making new pieces to replace the lost ones. Several close-ups reveal the contrast in tone, sharpness, relief and finish between new work and weathered adjoining fabric. This evidence is noted as compatibility and authenticity issues, not for what material or technique was used.

**Figure 2:** Kodla Moth during ongoing conservation: (a) overall exterior and scaffolded work zone; (b) surviving ornmented entrance; (c) major local loss exposing irregular masonry; (d) artisan handling a newly produced patterned terracotta element; and (e) visual relationship between weathered historic fabric and newly worked areas. Photographs by the author, 2 April 2026.

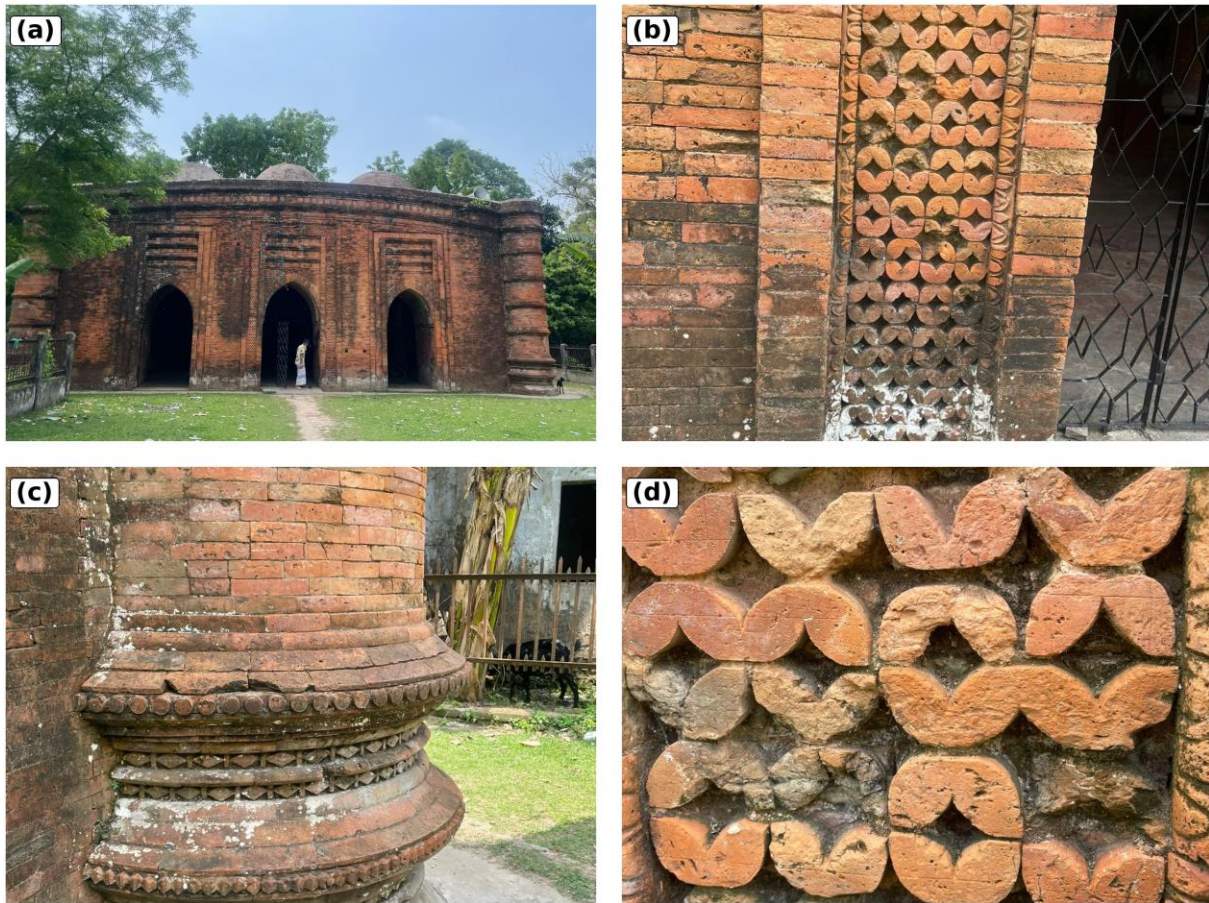
The exterior lower zones exhibit evidence of white deposits, staining, worn relief, loss at the edges and breakage. Many repetitive elements have chippings, gaps or breaks where backing or infill is exposed. This interrupts the rhythmic composition of both units and borders without obscuring the entire facade. The photographs illustrate what can be seen but do not identify the chemistry or cause of deterioration.

**Figure 4.** Nine-Dome Mosque: (a) overall facade; (b) doorway-adjacent repetitive decorative panel; (c) corner-turret molded bands; and (d) close view showing broken, eroded, or missing units and local discontinuity. Photographs by the author, 2 April 2026.

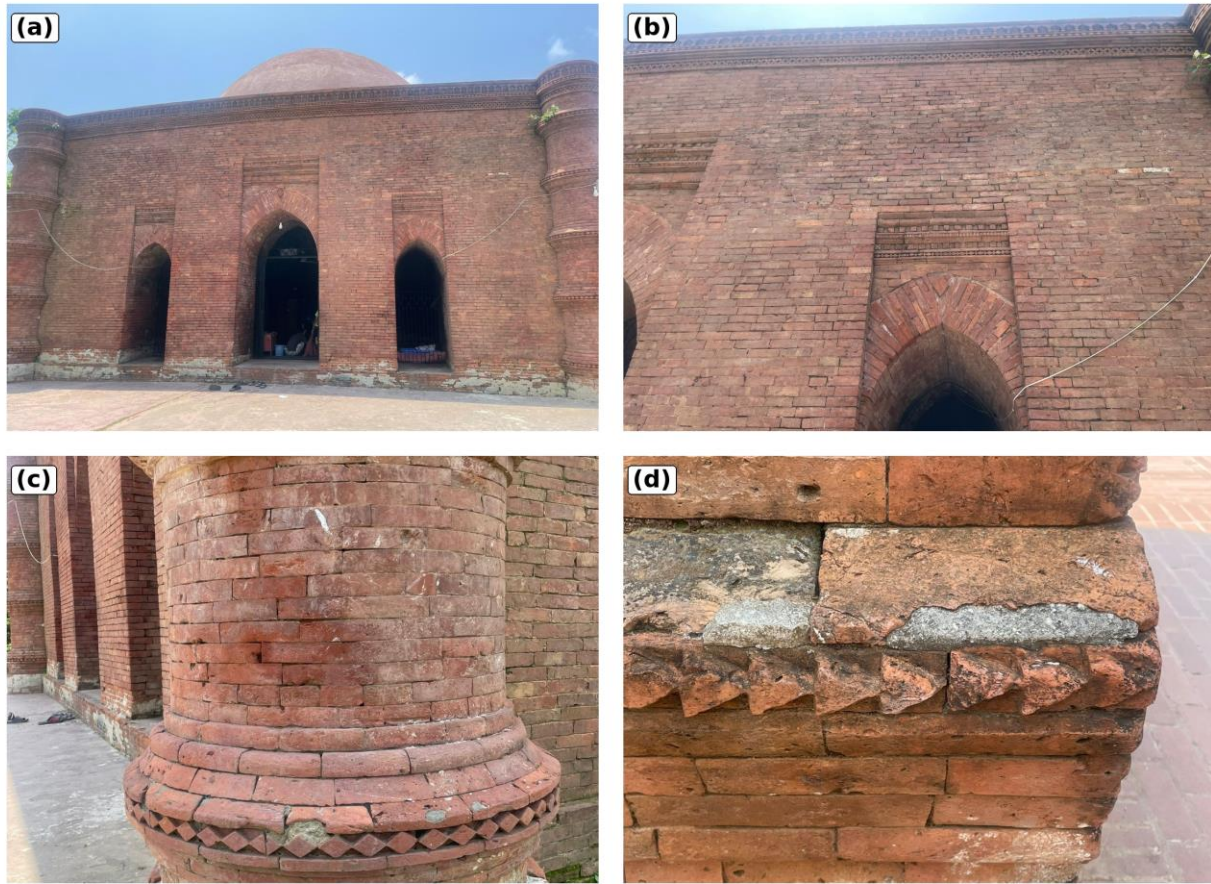
A closer look reveals chips or missing pieces of molding, open joints, displaced pieces, white stains, black stains or discoloration, patchy losses and exposed gray patch or infill in lower or turret areas. Since there are few decorative elements, a single break will interfere with the pattern. The main impact will thus be felt on unit, border and focal field level.

**Figure 5.** Singair Mosque: (a) overall facade; (b) entrance/cornice field; (c) corner-turret serial mouldings; and (d) close view showing chipped or missing units and local infill. Photographs by the author, 2 April 2026.
